The Setenave Dry Docks Rehabilitation

by Ivan Ramalho de Almeida, Thomaz José Ripper Barbosa Cordeiro, and José Paulo Veríssimo Maia Costa

Setenave is a general designation for a shipyard built in the early seventies, at the right shore of the Sado River, south of Lisbon, in Portugal. In 1991, an important structural rehabilitation of the reinforced concrete walls of the Setenave dry docks was performed. Repair was required to overcome the problems of generalized reinforcement corrosion, then evidenced by disaggregation of very large areas of the concrete cover (Fig. 1).

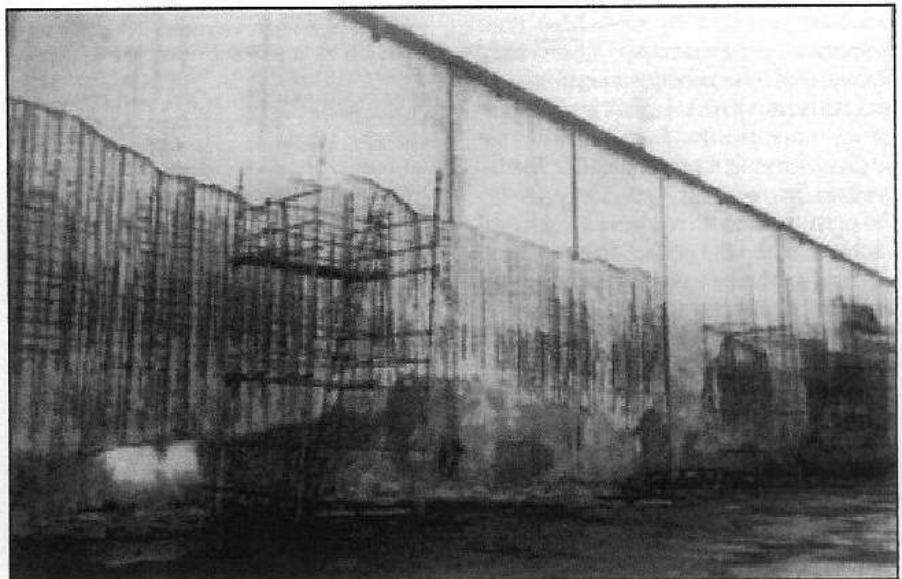
Simple visual observation of walls evidenced the intensity of structural concrete disaggregation (which reached more than 10 m² at some places) and the resulting exposure of corroded reinforcement. A preliminary quantification of damaged areas supplied the following data:

Fig. 1: Concrete disaggregation

- The investigation showed the presence of chlorides through diffusion, reaching values at the reinforcement level up to 0.3 percent of concrete mass.

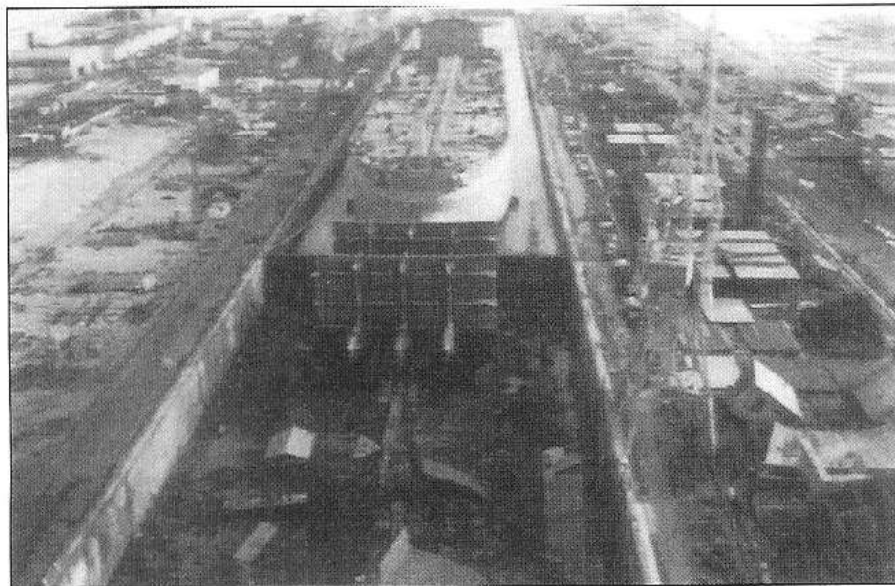
Fig. 5: The docks, again in operation, after the rehabilitation

- The good results obtained were certainly due to the careful attention given to the structural rehabilitation procedure from the start. A valuable output has already been obtained: the development of a pilot technology providing excellent technical results, and the re-opening of the normal operation of the docks (Fig. 5).
